Performance of FRP Connectors for Seismic Rehab of Michie Stadium

Orange Marshall
USACE ERDC-CERL
Orange.S.Marshall@usace.army.mil

The objective of this project order was to inspect two hundred and fifty (250) FRP composites patches used for service life extension of Michie Stadium at the USAMA, West Point, NY, using Acoustic Guide Wave technology

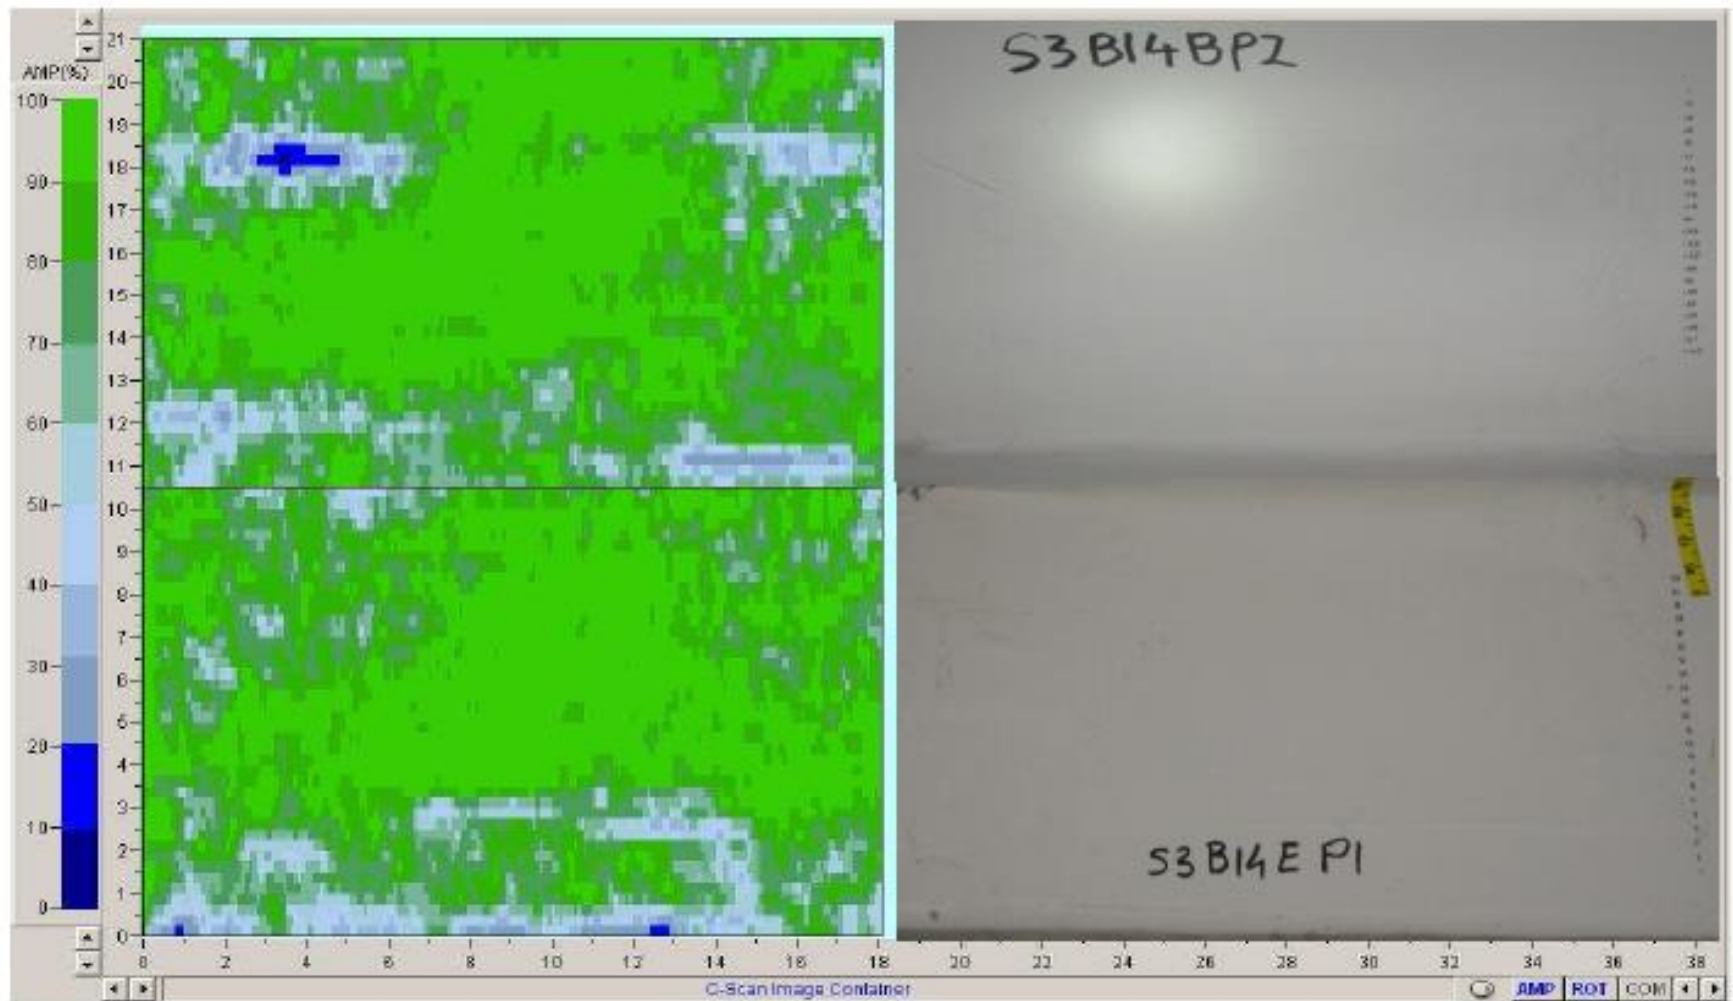
Performance Evaluation C-Scan

Delamination ↓ Good ↑

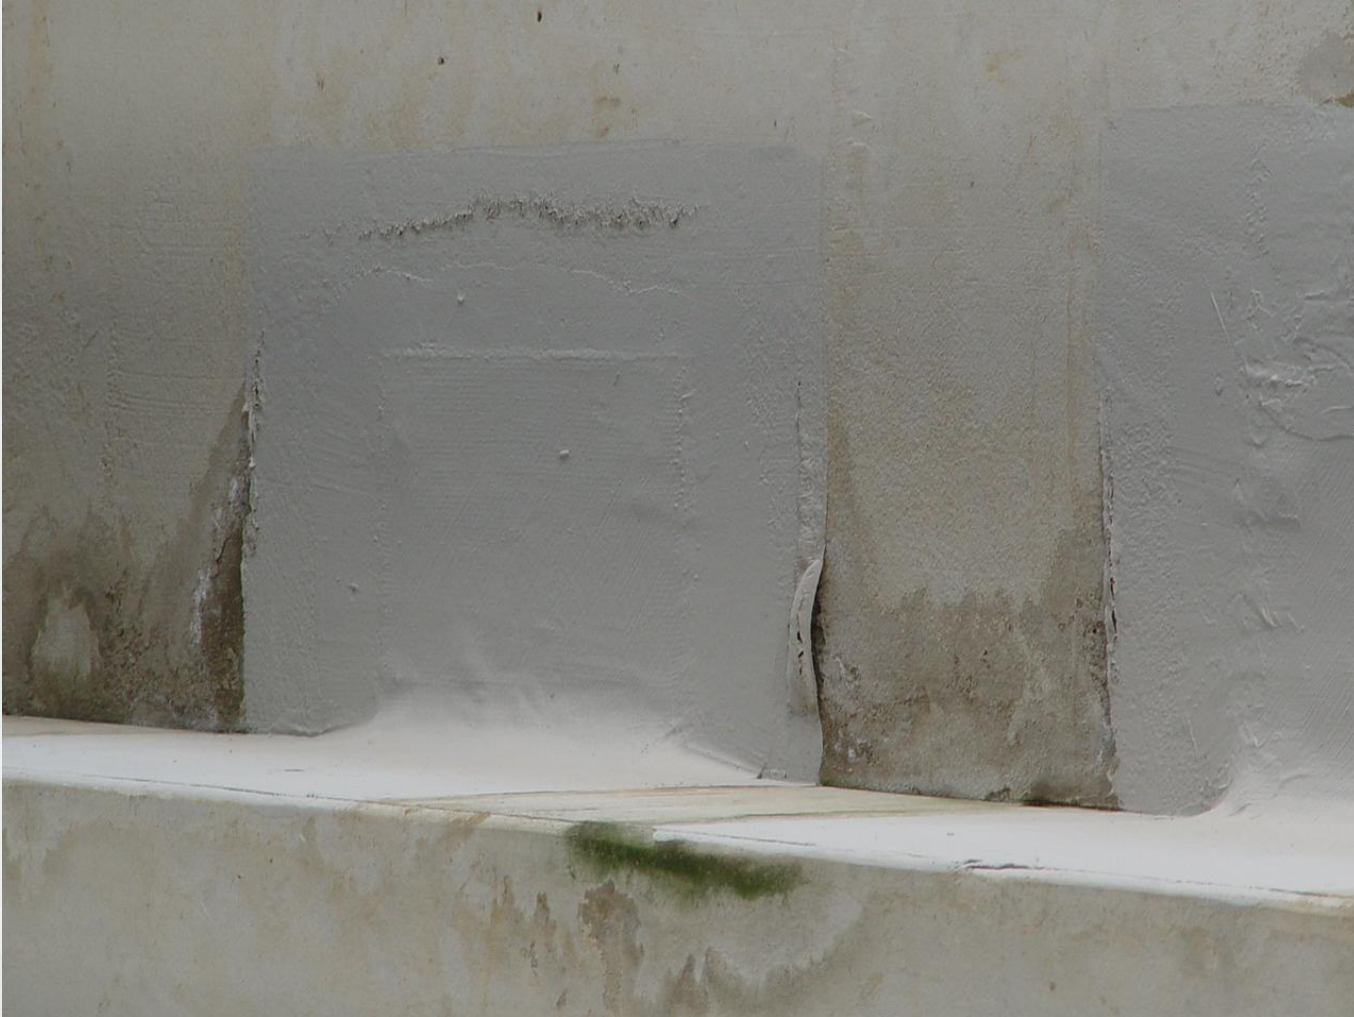
Results

- The results were obtained in the form of C-scan images in which the color pixel of the different areas in the image is related to the amplitude of the acoustic signal reflected from the different areas of the panel.
 - ▶ In this case, the green areas are associated with signals reflected from good areas of the FRP panel, whereas the blue areas of the C-scan are associated with delaminations in the panel.
- Section-6 on lower tier and section-14 on upper tier should be investigated for bond failure.
